Aviation Investigation Final Report

Location:	Jolon, California	Accident Number:	DCA22FA082
Date & Time:	February 16, 2022, 09:58 Local	Registration:	N542AJ
Aircraft:	JOBY AERO INC JAS4-2	Aircraft Damage:	Substantial
Defining Event:	Part(s) separation from AC	Injuries:	N/A
Flight Conducted Under:	Part 91: General aviation - Flight test

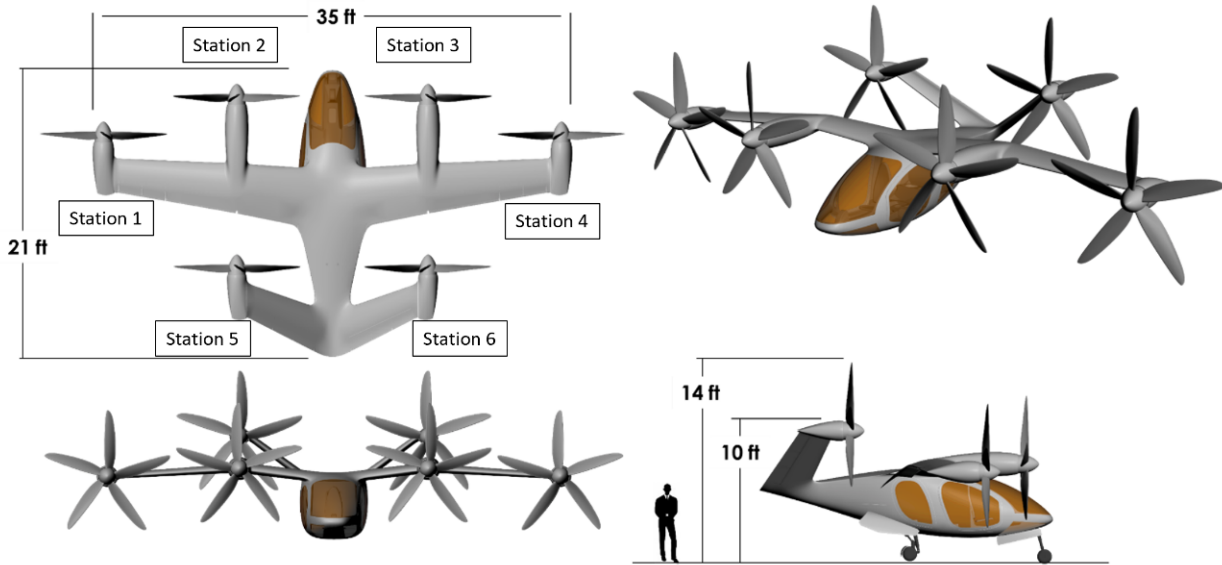
Figure 1. Depiction of a JAS4-2 aircraft (Source: Joby Aviation)

The aircraft was configured with six tilting propellers directly driven by six dual-powered electric motors supplied by power from four battery packs. The six electric propulsion unit (EPU) stations are identified numerically based on location as station 1-outboard left wing, station 2-inboard left wing, station 3-inboard right wing, station 4- outboard right wing, station 5-left tail, and station 6-right tail. Each of the six variable pitch propeller assemblies were equipped with five blades and actuated by a single variable pitch actuator driving a mechanical pitch change mechanism.
